# Manhole Inspection Summary

Manhole # S3100\_017MH

Insp Date: **4/25/07 12:16 PM**

**Location** Address: **424 FAWCET ST**

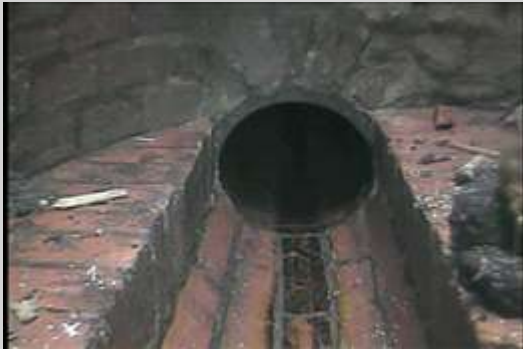
### 8 in. Circular Gravity Sewer Pipe Out @ 12 O'Clock

Pipe Material: **Clay** ☐ Pipe Lined

Invert Depth: **8.85** (ft.) Flow Characteristics: **Slow**

Deposits: ☒ None ☐ Mud ☐ Sludge ☐ Debris ☐ Grease

Infiltration: **None** Pipe Seal Cond: **Unknown**

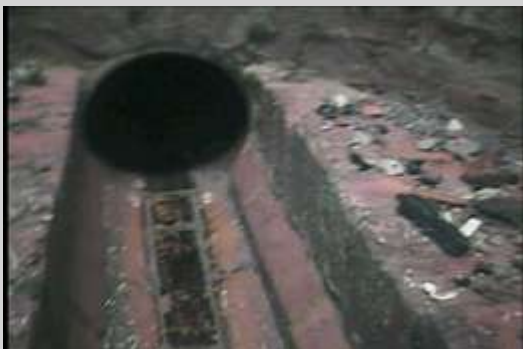
### 8 in. Circular Gravity Sewer Pipe In @ 6 O'Clock

Pipe Material: **Clay** ☐ Pipe Lined

Infiltration: **None** Pipe Seal Cond: **Unknown**
